Use of Opteform® to Repair Acetabular Osteolysis

Series A, Number 2

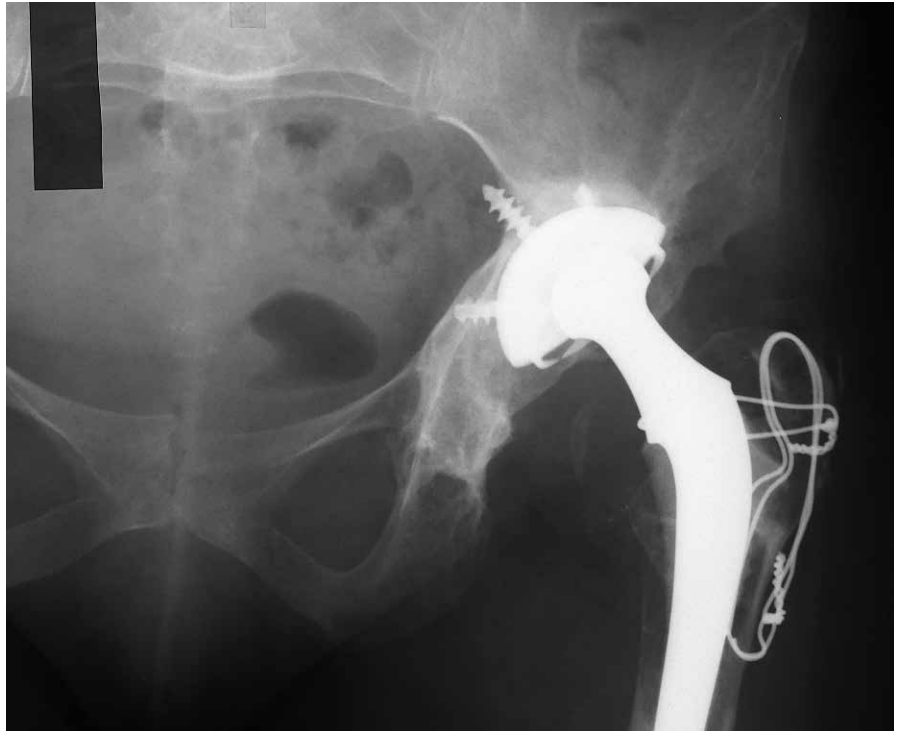
1)

Fig 1. Preoperative: The left acetabular cup has migrated superiorly indicating loosening. Also note the radiolucency along the femur and the asymmetrical polyethylene wear.

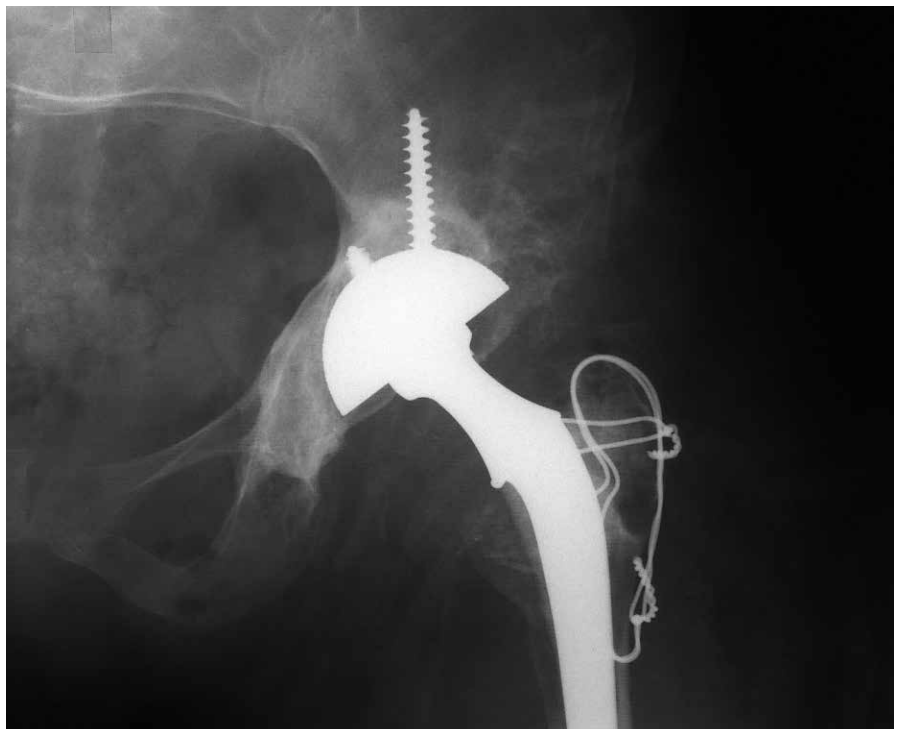
2)

Fig 2. Immediate postoperative: new cup and implanted Opteform around the cup.

At operation the femoral stem was well fixed. However, the acetabular component was loose and was subsequently removed. Acetabular bone was reamed to expose fresh host bone. There were bony defects in the anterior, posterior, medial and superior portions of the acetabulum. A 75mm and a 45mm disk of Opteform®, providing a total graft volume of 23cc, were warmed and pressed into the defects. A 48mm cup with a 22mm ID acetabular insert was placed. The cup fixation was supplemented with two 6.5 mm screws, applied superiorly (Figure 2). At 10 weeks postoperatively, the patient resumed full activity without external support.

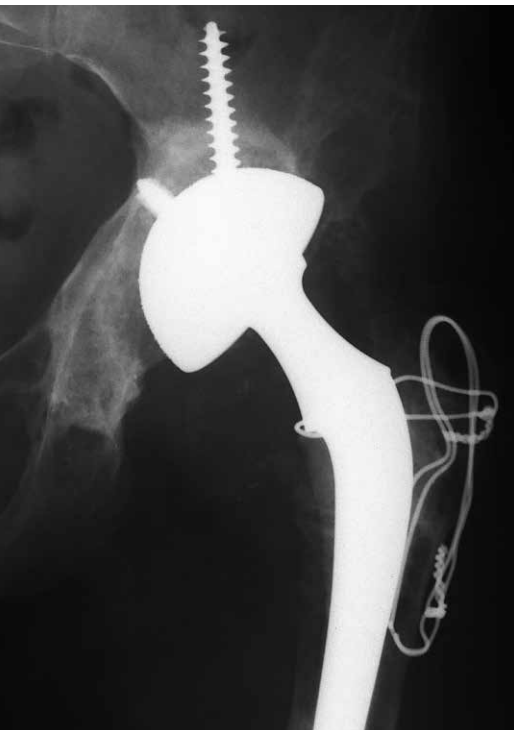
3)

The patient returned six months postoperatively after developing acute pain. Radiographs showed that the acetabular component had rotated into a vertical position (Figure 3). At operation the defects observed six months previously were well healed, and no additional bone graft was required during this revision. A biopsy was taken at the site of the previously placed Opteform[®] allograft (Figure 4). Histological analysis indicated new bone growth and remodeling throughout the Opteform[®]. The displaced acetabular cup was revised with a 52mm acetabular cup using four 6.5mm screws to augment the fixation.

Fig 3. Ten weeks postoperative: The medial edge of the acetabular cup has rotated laterally, tilting the cup vertically. Note the radiolucent gap on the medial edge indicating the cup's previous position.

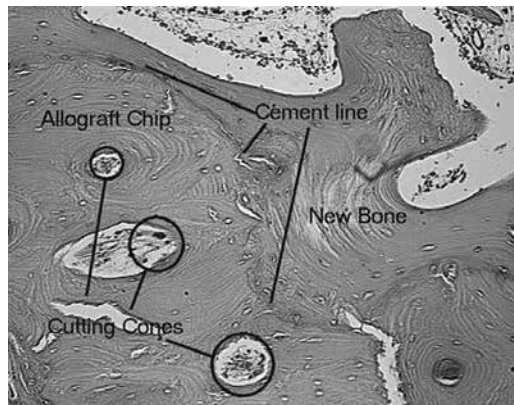
4)

Fig 4. Histological sample of the bone graft site. New bone has grown amidst the Opteform[®] allograft chips and is continuing to remodel as indicated by the cutting cones.

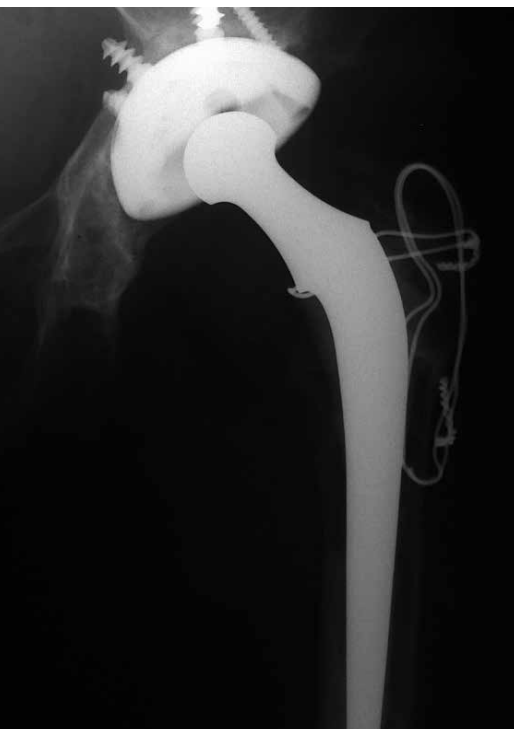
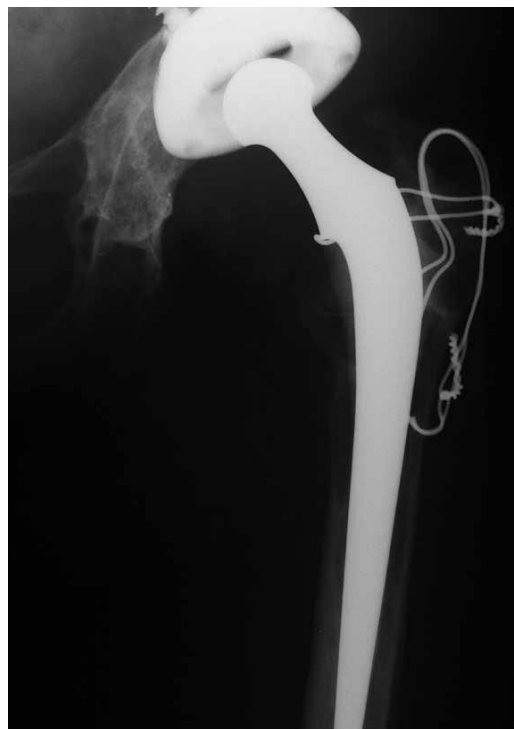
Four months after the most recent revision operation, the patient was walking well with one crutch. Radiographs demonstrated the prosthetic components in good position with no evidence of complications (Figures 5 & 6). The displacement of the acetabular cup was thought to be due to the inadequate fixation of the acetabular cup into healthy host bone. The use of Opteform[®] during the first procedure improved the bone quality at the site thus allowing for better fixation during the subsequent procedure.

Fig 5 & 6. One month (left) and four months (right) postoperative: Note the trabeculation of the bone graft and the lack of movement of the cup.
